Section 206- Flood Plain Management Services Program

**SOUTHEAST AREA DRAINAGE
DISTRICT STUDY,
EAST PROVIDENCE, RHODE ISLAND**

March 1996

**US Army Corps
of Engineers**
New England Division

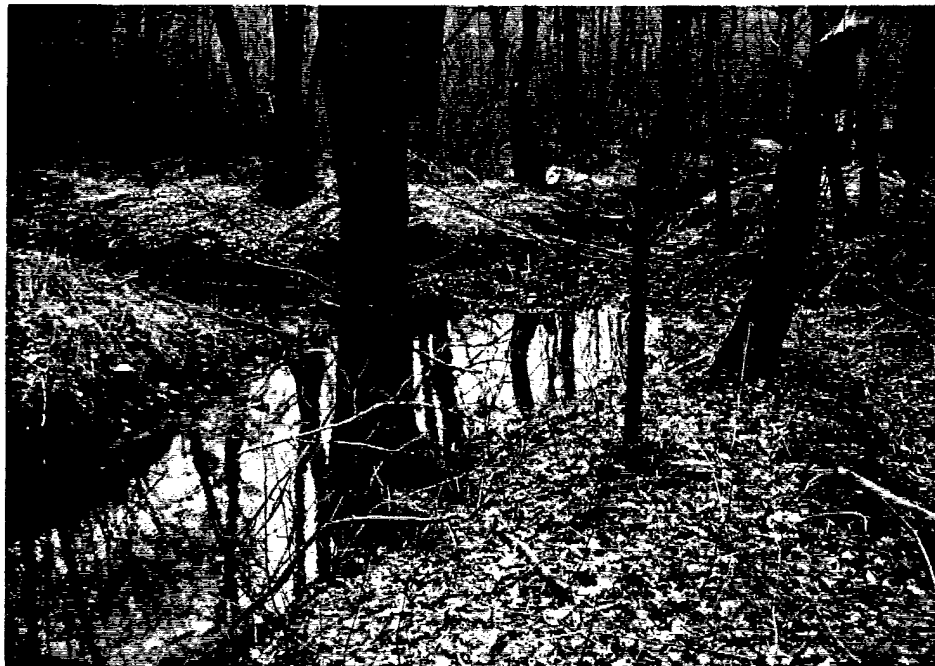
Photo 2 - Normal flow path turns to east in vicinity of Thurston Street. Secondary channel continues to the south.

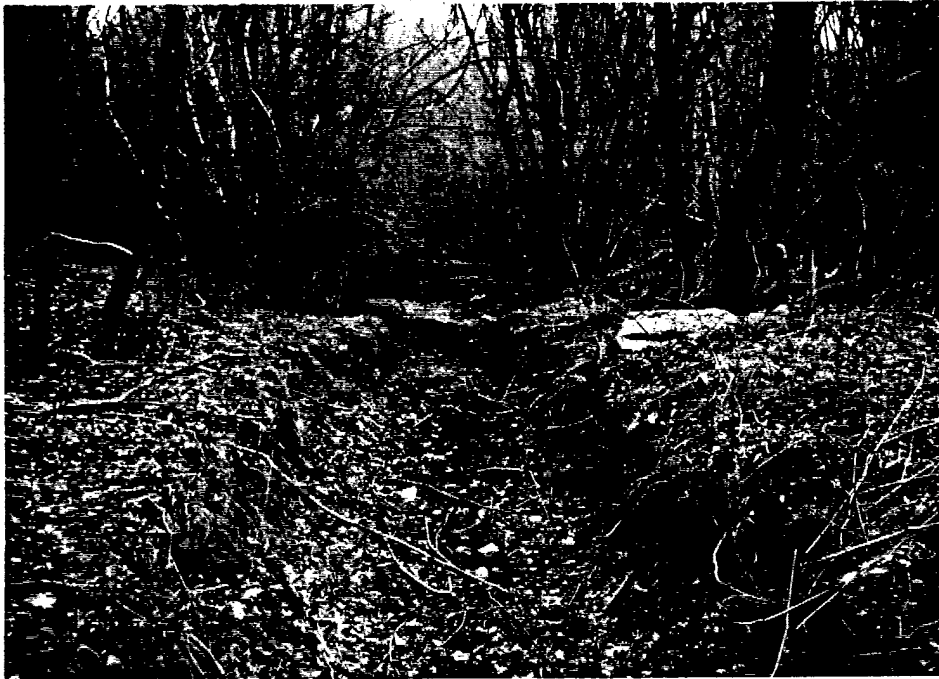
Photo 3 - Upstream of Rounds Ave. No flow in secondary channel.
Looking north from Rounds Avenue.

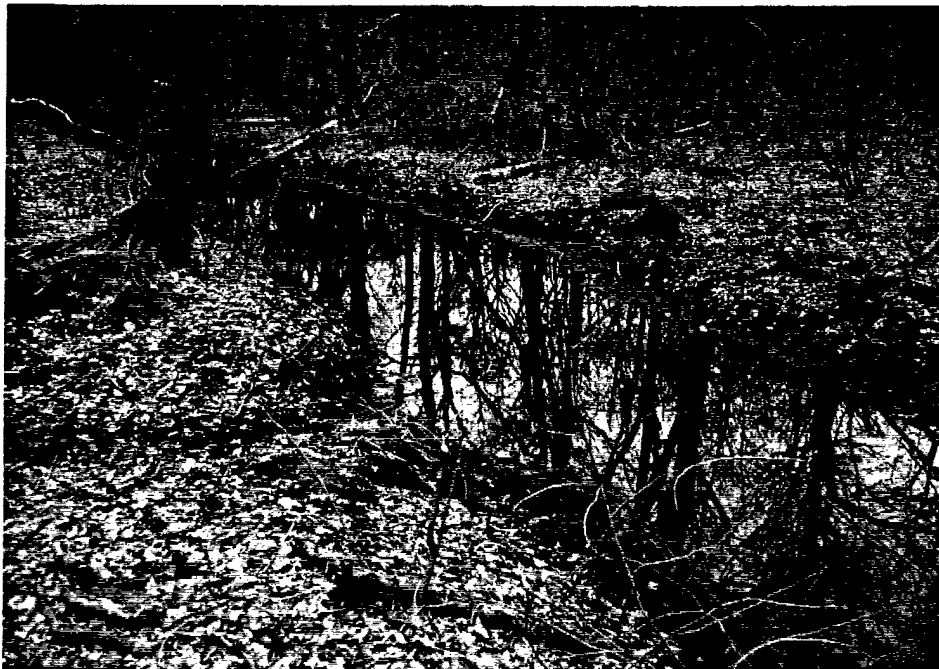
Photo 4 - Upstream of Rounds Ave. & Tanglewood Drive.
No flow in secondary channel, looking northeast.

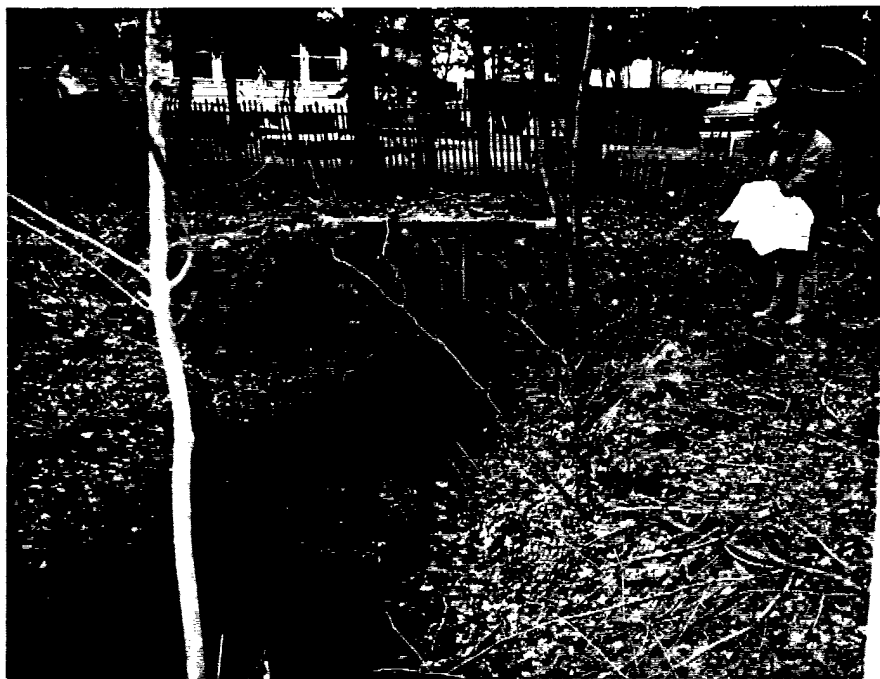
Photo 5 - Normal flow path enters 48" diameter pipe
@ Tanglewood Drive and Rounds Avenue.

Minor sediment buildup in pipe of about 1-2". Stone and mortar headwalls are in good condition with only some minor areas of missing mortar at the wingwall. A trash rack/grate is attached to the headwall. The pipes of the grate are corroded and bottom portions of the pipes are missing. (See Photo 5)

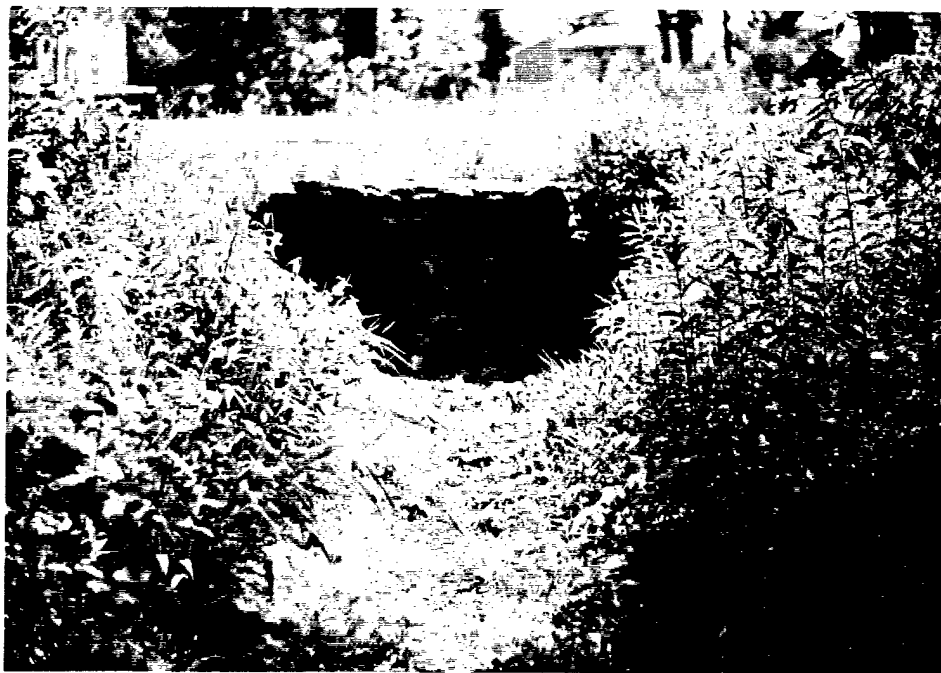
Photo 6 - Upstream end of culverts at Rounds Avenue.

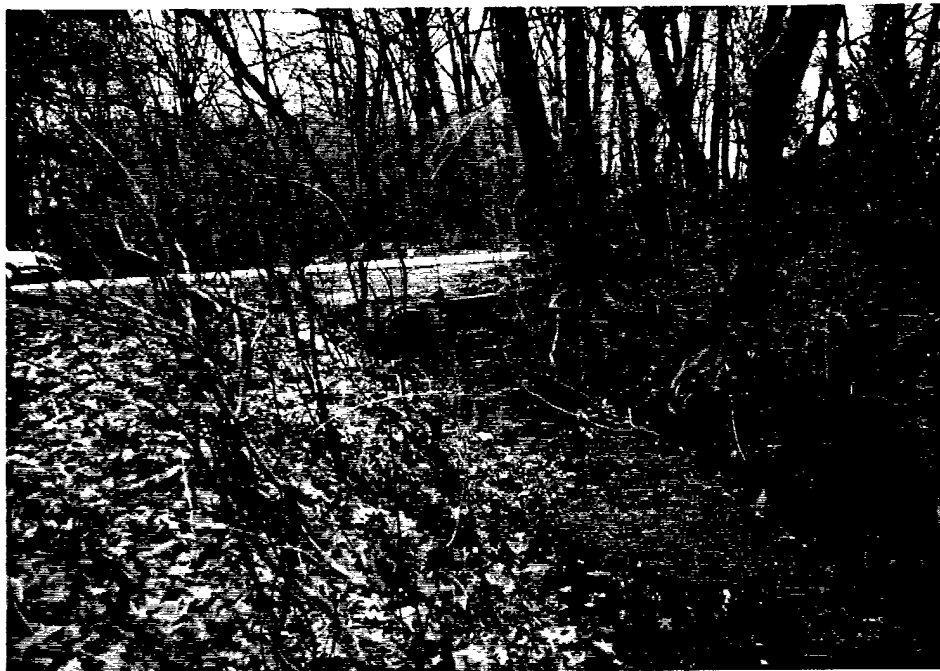
Photo 8 - Downstream of Glenrose Drive. 30" diameter pipe.

Stone/mortar headwall at upstream end has some loose stones and missing mortar. Concrete headwall at downstream end is in good condition. There are minor spalls and chipping of concrete pipe. There is no apparent settlement or deflection of the culvert. Approximately 70' downstream is the confluence of the main flow from Annawomscutt Brook which discharges from the drainage network. (See Photo 8)

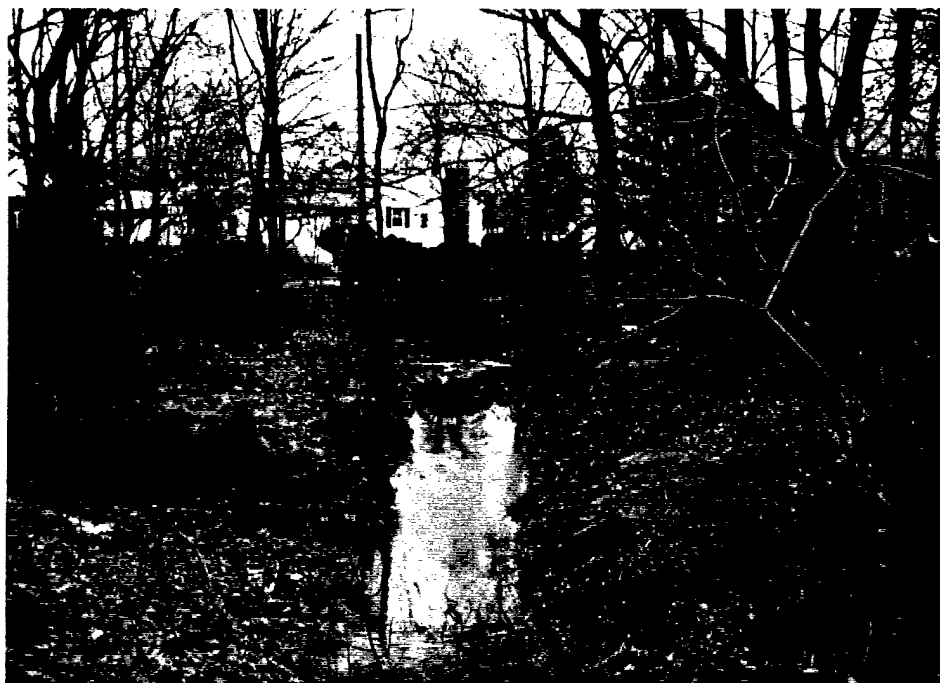
Photo 9 - Downstream of Glenrose Drive. Note two 36" diameter pipes is outfall for drainage network conveying normal flow path. Secondary channel enters at the left.

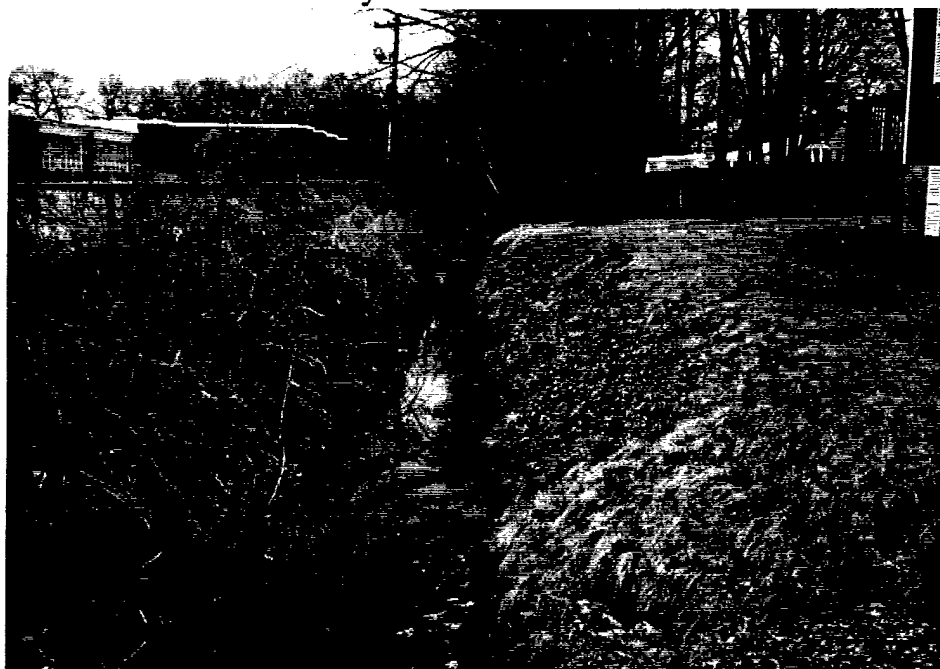
Photo 10 - Typical channel looking upstream (north) from Legion Way.

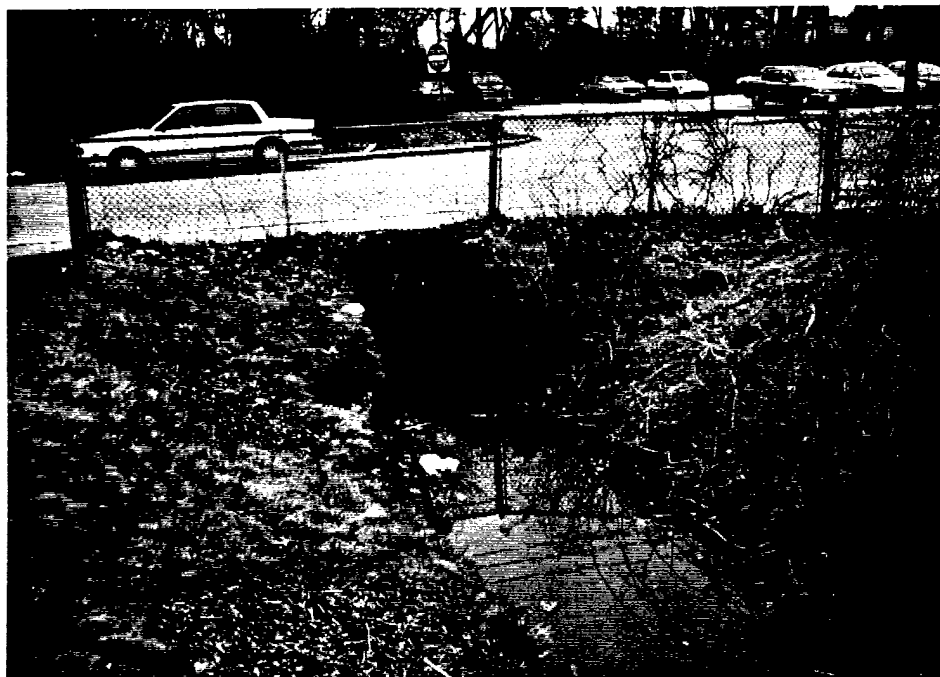
Photo 11 - Upstream @ Legion Way looking south.

Stone/mortar headwalls and wingwalls are in fair condition with some minor spalling and cracking of mortar. (See Photo 11) No visible settlement or deflection of walls, culvert, or roadway. Downstream outlet was not observed due to inaccessibility. There is also an 18" diameter pipe discharging to the brook from the west bank just upstream from the culvert inlet. It appears this pipe drains the adjacent school property.

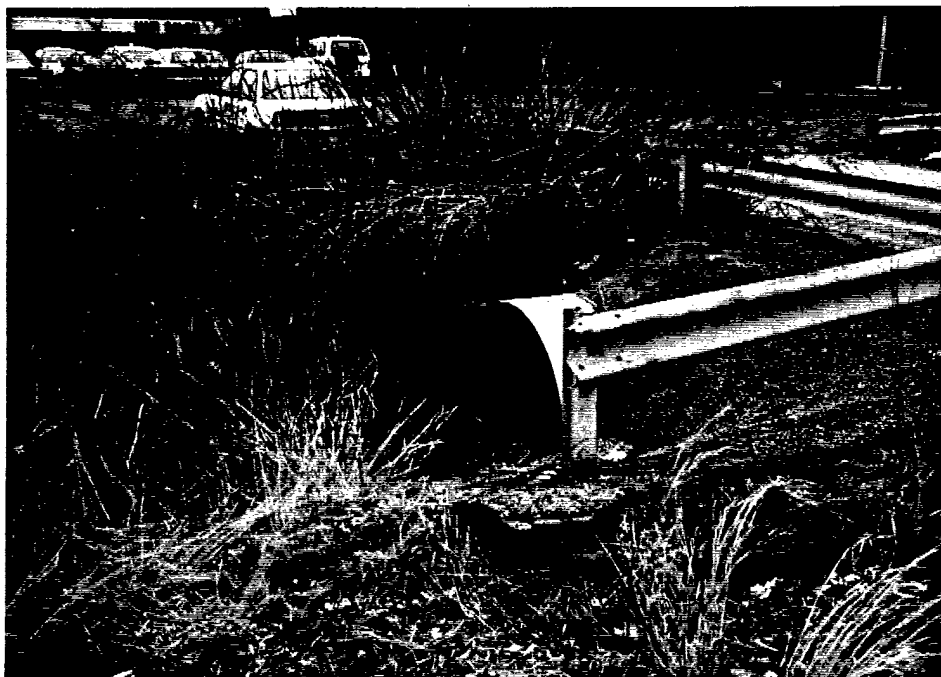
Photo 13 - Downstream end of north access road at plaza parking lot.

Downstream: Heavy sediment buildup and vegetation at outlet of west pipe, similar to upstream end. Erosion of the east downstream bank has occurred at the top with the loss of pavement material. However, this condition appears to be due to surface runoff from the parking lot rather than streamflow conditions during rain events. There is heavy vegetation along both banks. Heavy vegetation prevented obtaining invert elevation of west culvert pipe. (See Photo 13)

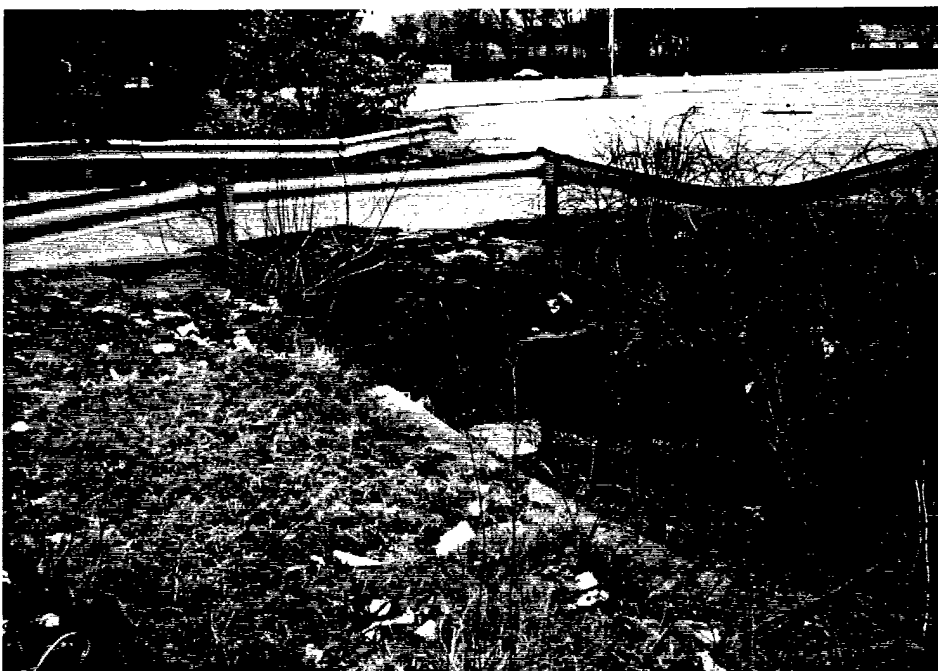
Photo 14 - Downstream end of south access road at plaza parking lot.

Headwalls and wingwalls constructed of stone masonry. Portions of both upstream and downstream headwalls have loose stones and settlement of stones in some areas. (See Photo 14) There appears to be no settlement or deflection of either pipe barrel. The west pipe is composed of two material types. The inlet is a corrugated metal pipe and the outlet is a concrete pipe. It is not apparent where this change of material type takes place within the overall length of the culvert.

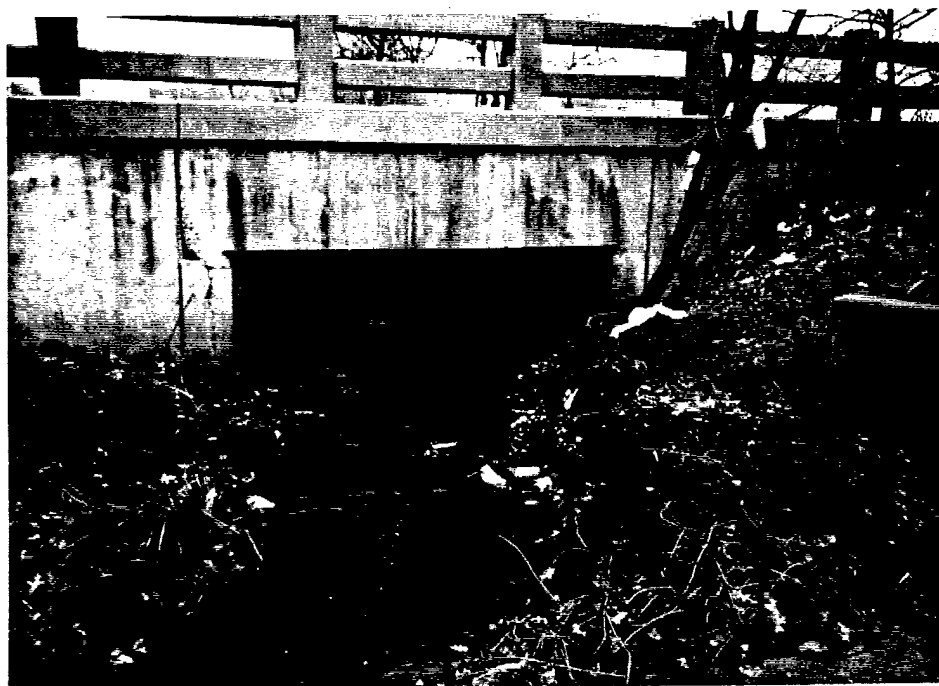
Photo 15 - Downstream @ Willett Avenue. Note headwall on right for 3.5' diameter drainage pipe.

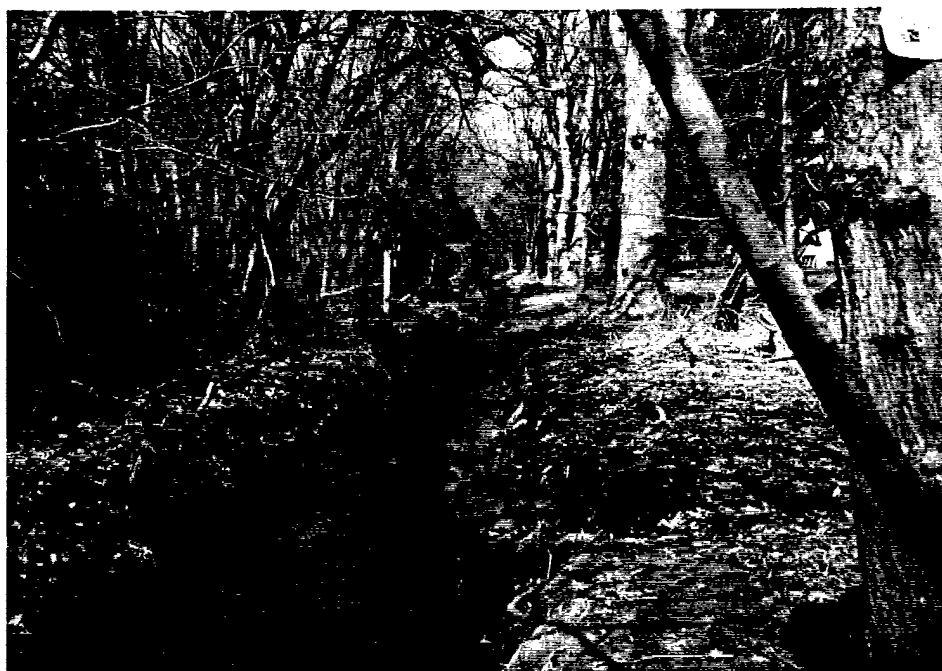
Photo 16 - Typical brook configuration. Looking upstream from Promenade Street.

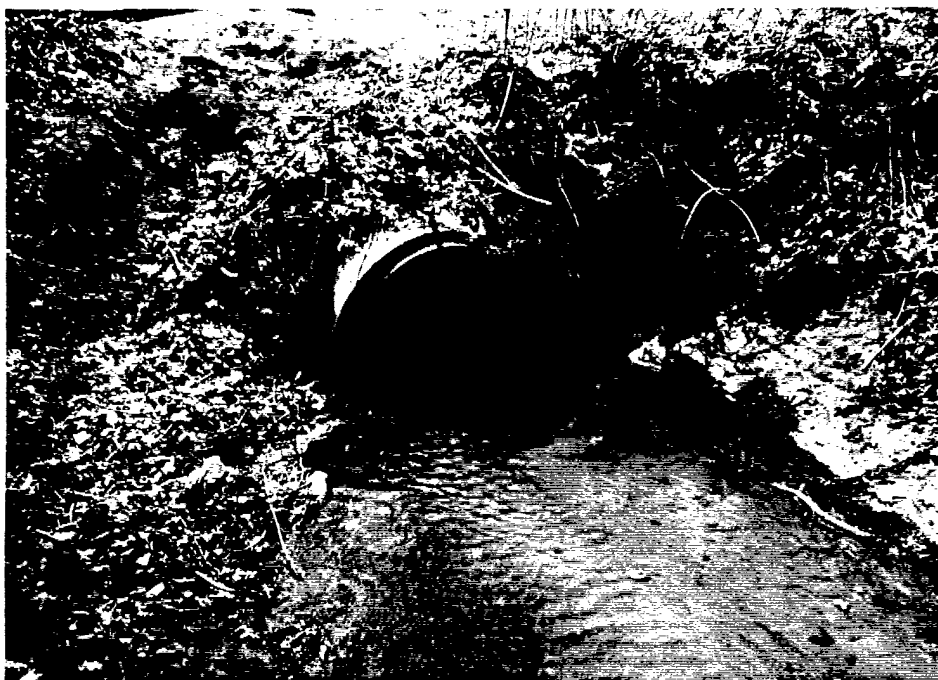
Photo 17 - Upstream end @ Promenade Street.

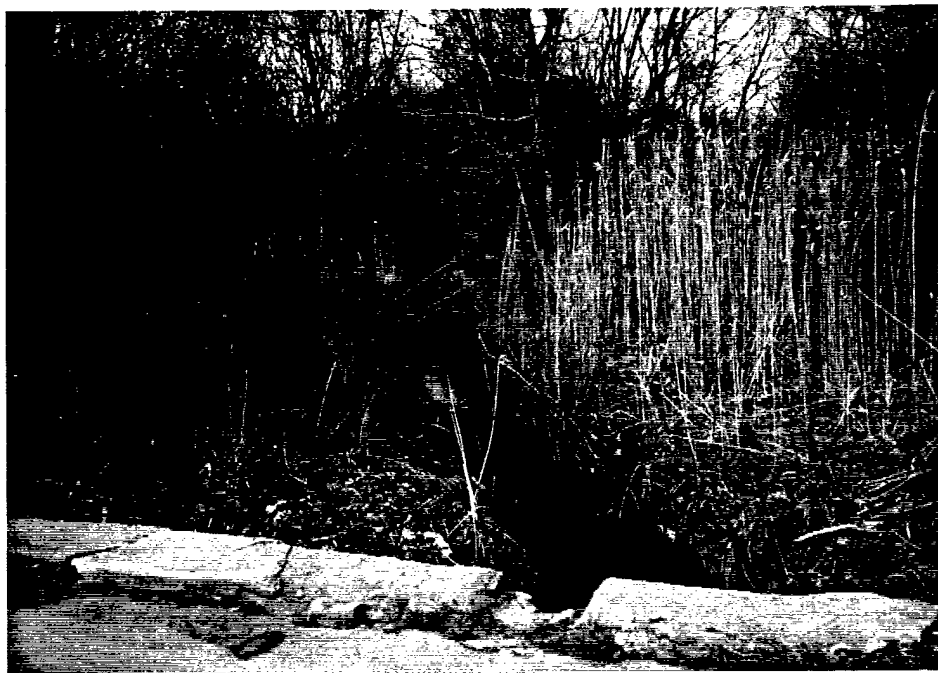
Photo 18 - Typical channel configuration. Looking upstream from Haines Park Road.

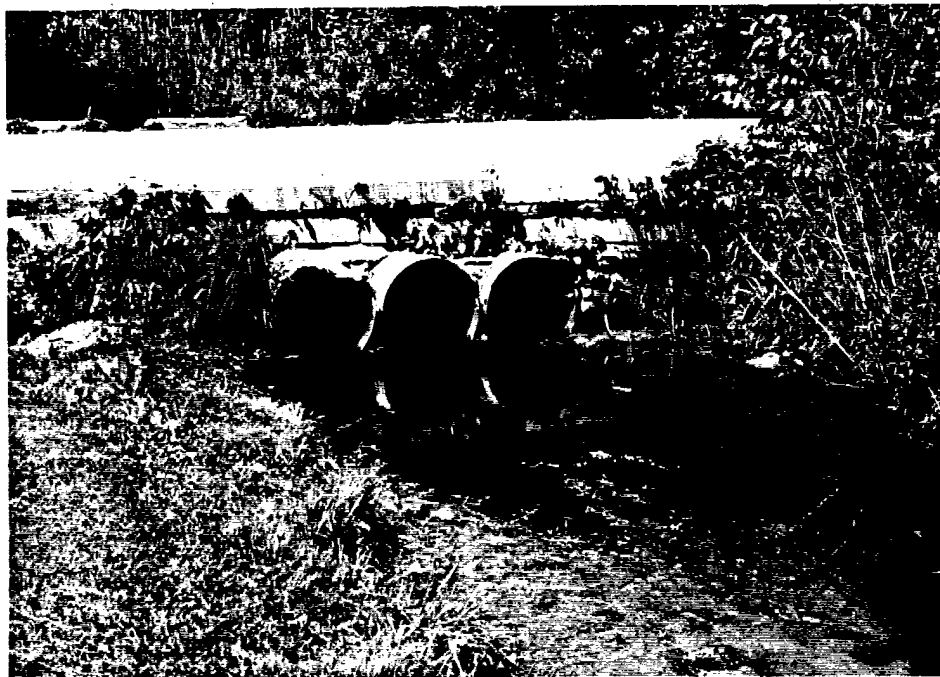
Photo 19 - Downstream end of Haines Park Road culverts.

No significant deterioration of pipe or deflection or settlement is apparent. Minor silt buildup (1-2") at upstream end of center culvert. (See Photo 19)

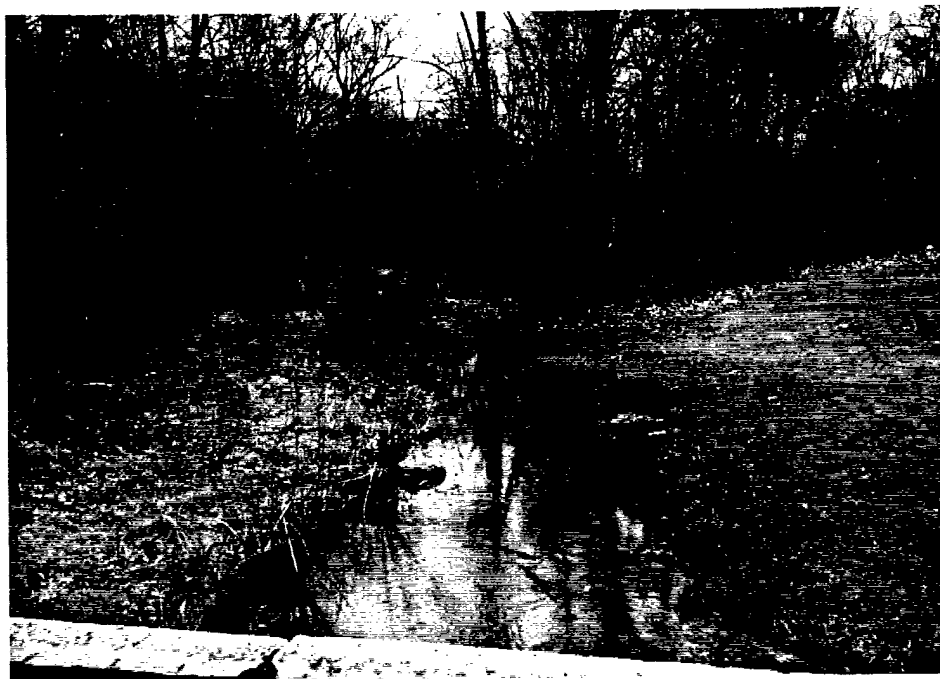
Photo 20 - Typical channel configuration. Looking downstream from Haines Park Road.

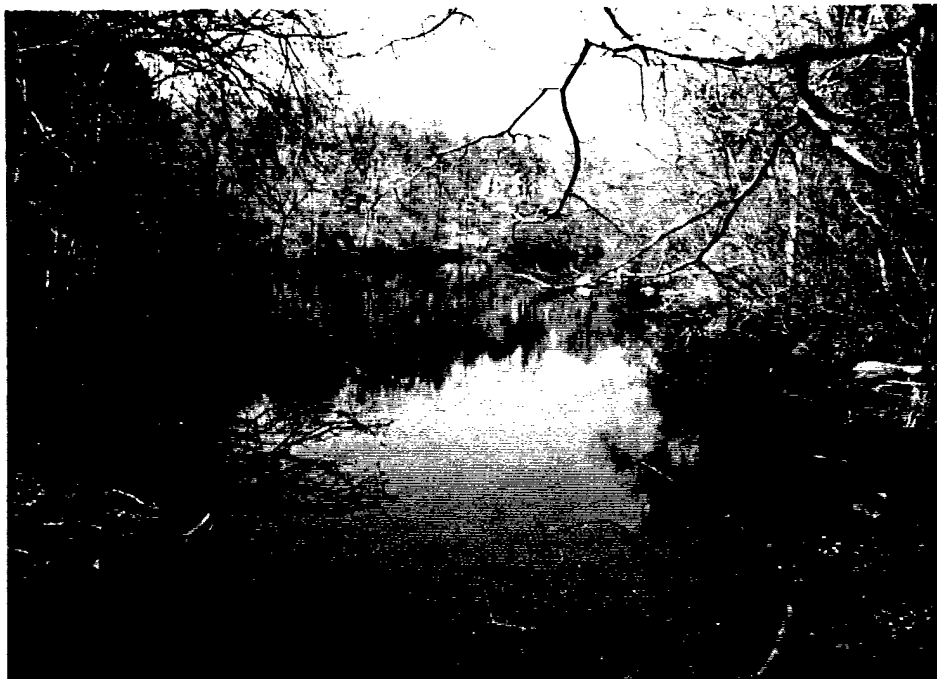
Photo 21 - Looking upstream north of bike path.

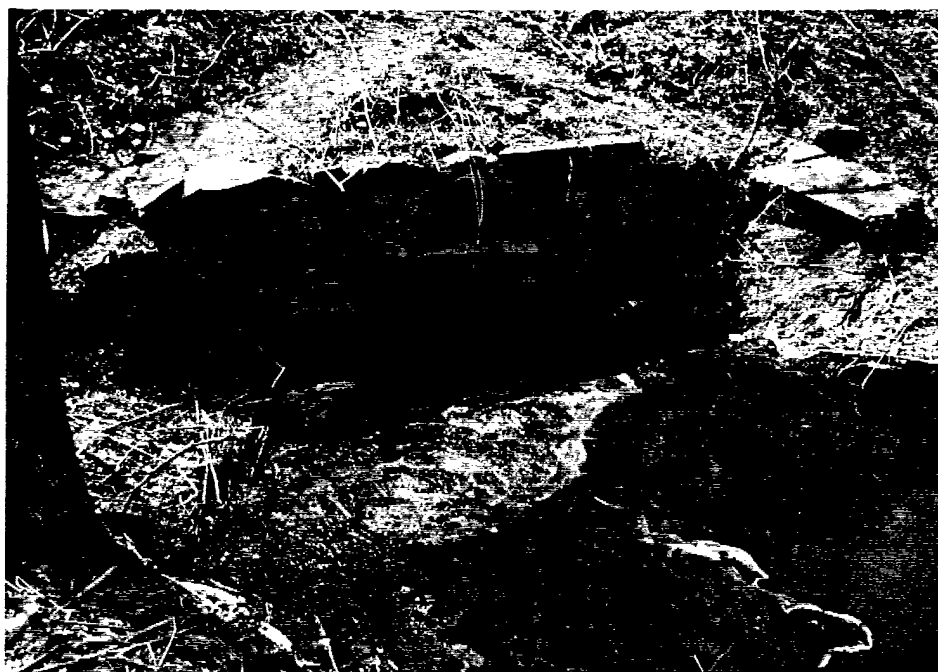
Photo 22 - Upstream end of stone culvert under bike path.
